**Beaver Dam - White River, Arkansas**

# **Beaver Dam Secant Pile Wall Completion Report**

**OCTOBER 1995**

3. REPORT TITLE BEAVER DAM SECANT PILE WALL COMPLETION REPORT . . . VOLUME 1		2b. GROUP
4. DESCRIPTIVE NOTES (Type of report and inclusive dates) FINAL CONSTRUCTION COMPLETION REPORT

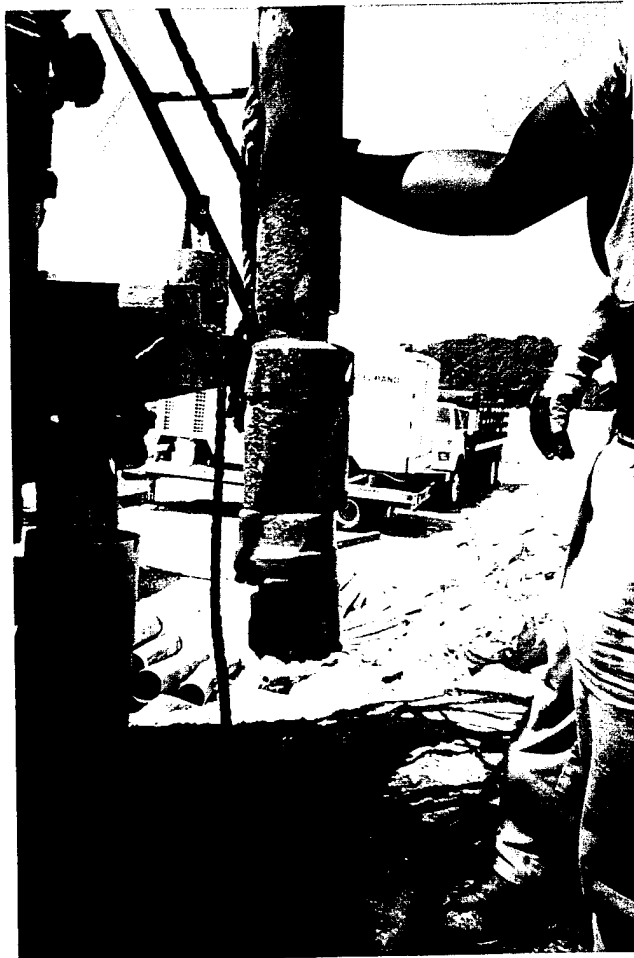
**PHOTO No. 3**

ODEX air hammer bit with under reamer extended (July 95).

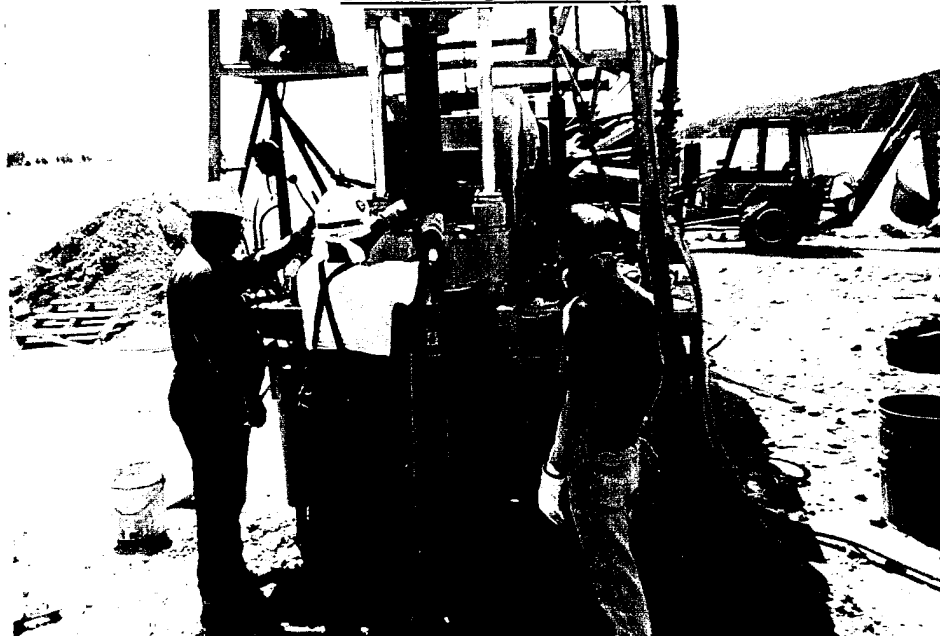
**PHOTO No. 4**

ODEX hammer being put into 6" ODEX casing (July 95).

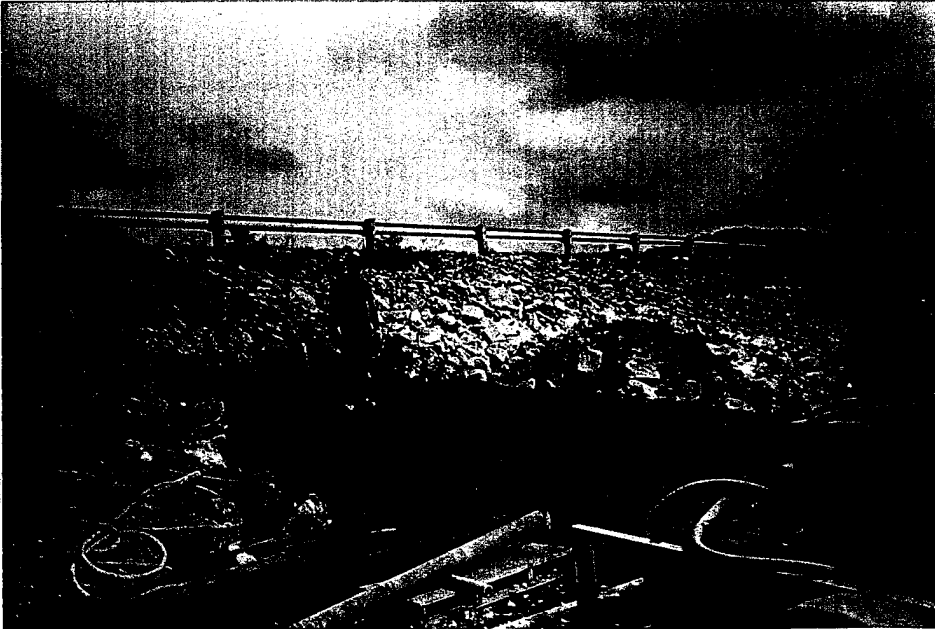
**PHOTO No. 10**

Clay access ramp constructed into Beaver Main embankment (May 95)
